### **REPORT ON THE GREGOIRE BARN FORMERLY THE COLBURN BARN 239 PROSPECT HILL ROAD RUMNEY, NEW HAMPSHIRE**

**JAMES L. GARVIN  
ARCHITECTURAL HISTORIAN  
SEPTEMBER 20, 2009**

This report is a summary of observations of the barn of the Gregoire family farm, Maple Grove Farm, at 239 Prospect Hill Road in Rumney, New Hampshire. The barn was inspected on the morning of September 19, 2009. The purposes of the inspection were to estimate the date of the barn, to assess its architectural integrity, and to identify its character-defining features as an aid to future planning for preservation of the building.

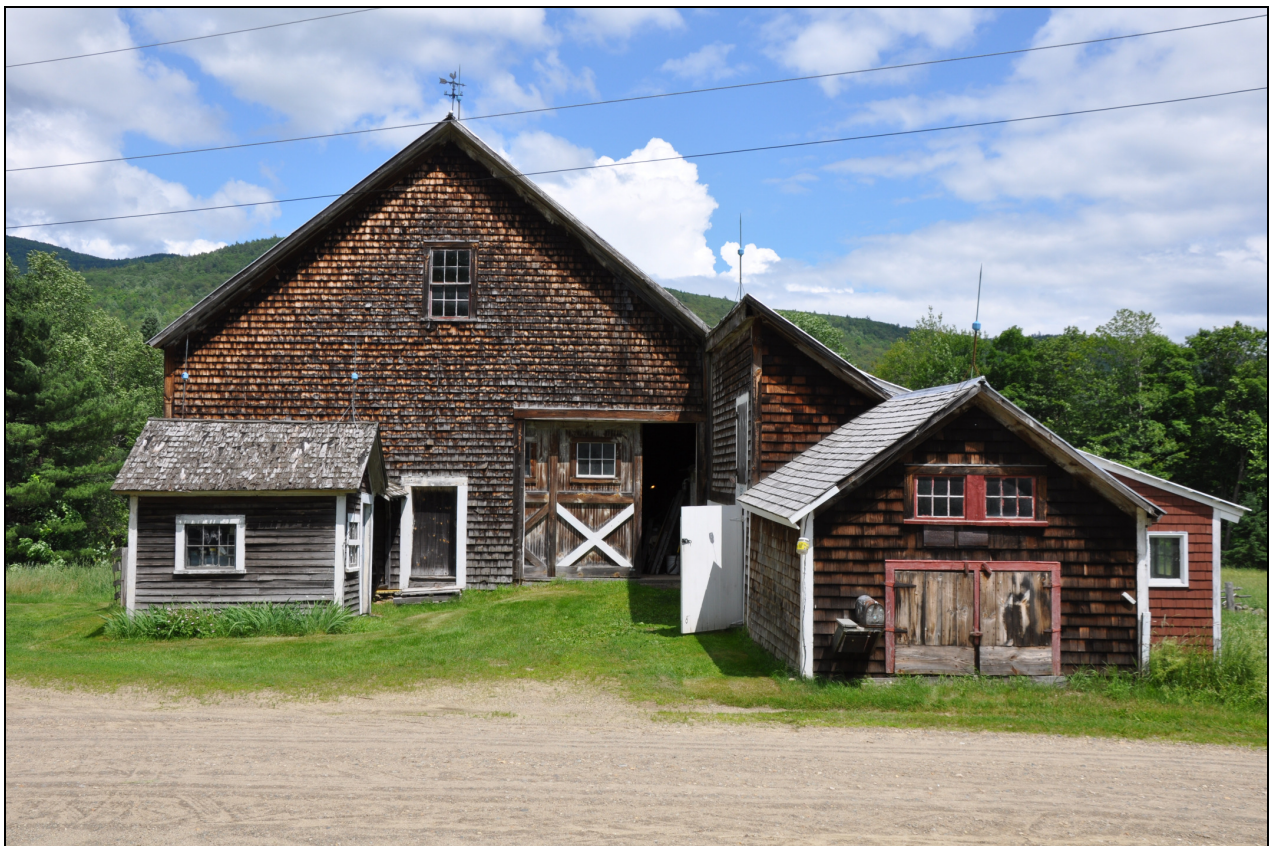
*Gregoire Barn, Rumney, New Hampshire, July 3, 2009, west (front) elevation. Photograph by David Starbuck.*

*Description:* The Gregoire Barn is a rectangular, gable-front barn measuring just over 33 feet in width and 48 feet in length. As seen in the photograph above, the front (west elevation) of the barn is covered with wooden shingles. The same wall covering is employed on the other elevations of the main barn and the stable addition on the east, except that the rear (east) gable of the barn is left un-shingled and the vertical sheathing boards of the gable are exposed to the

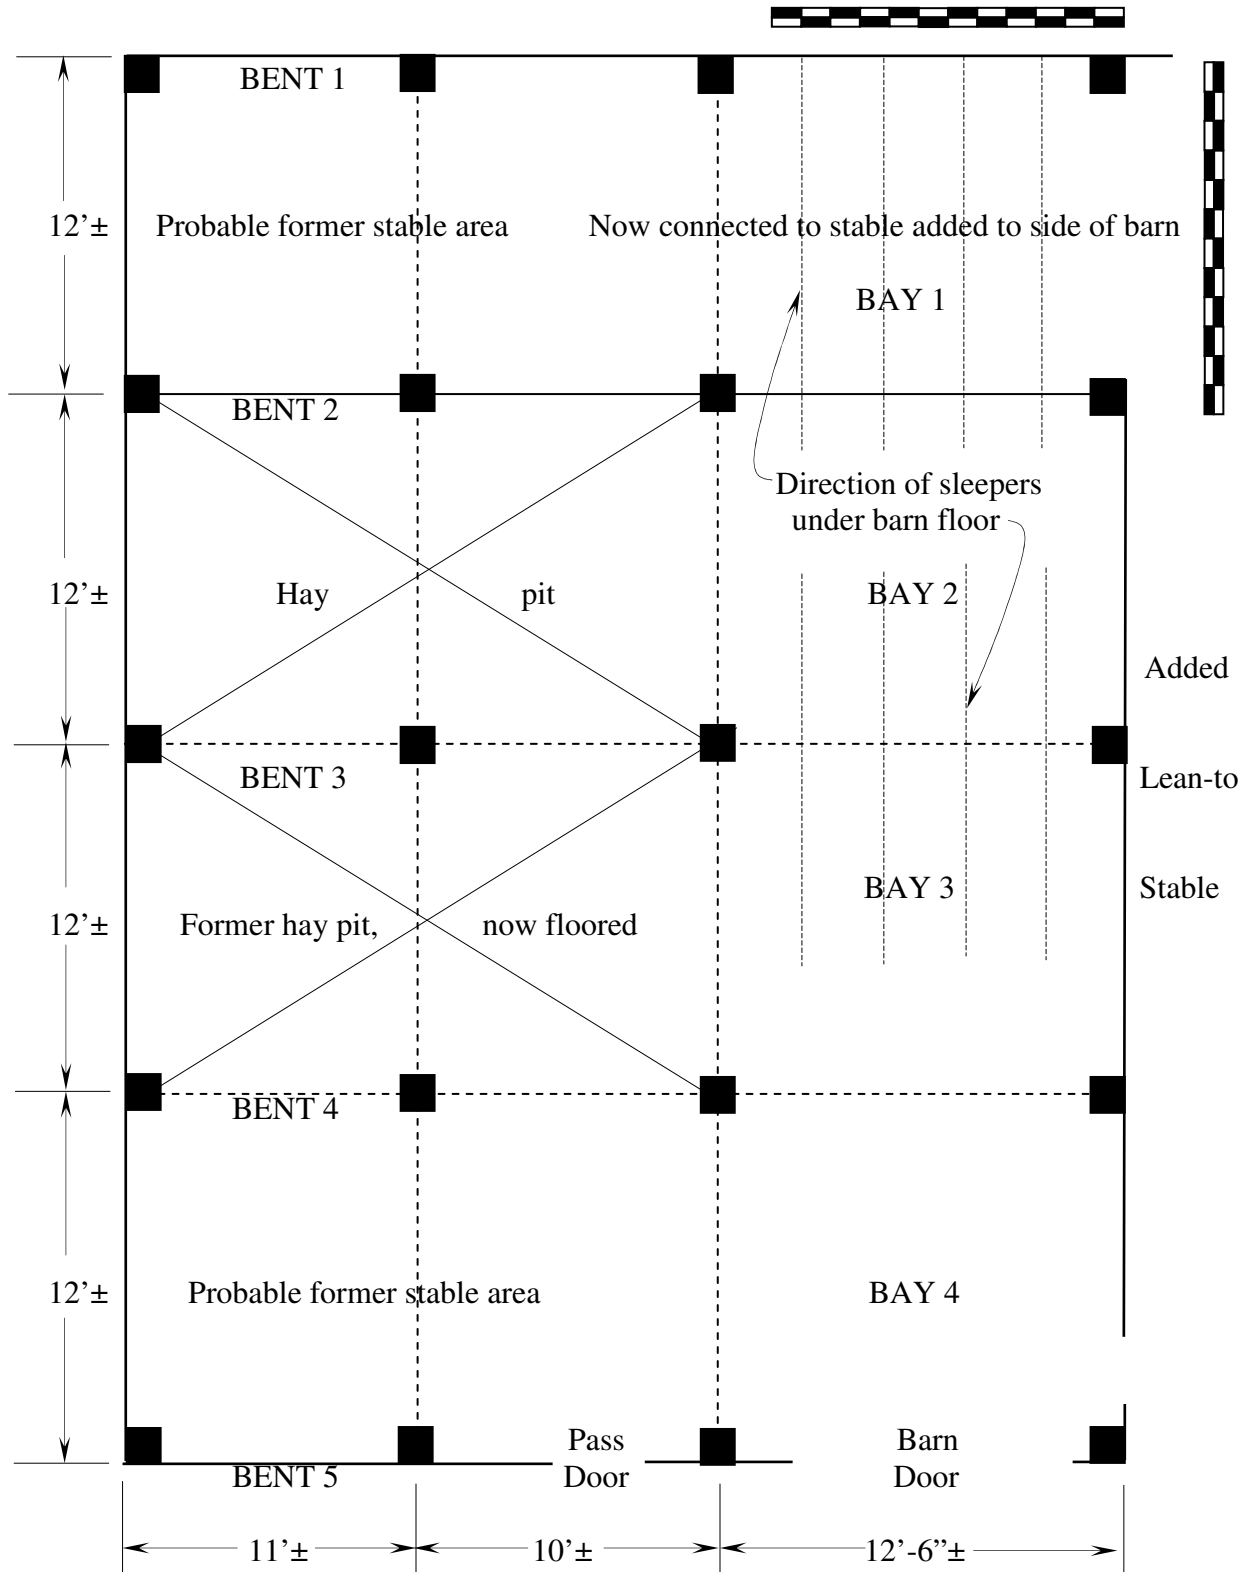
weather. The northern two-thirds of the north elevation of the barn are clapboarded rather than shingled. The barn frame was not measured carefully, but is composed of five bents placed about 12 feet on centers, for a total length of 48'-6," as shown in the schematic floor plan below:

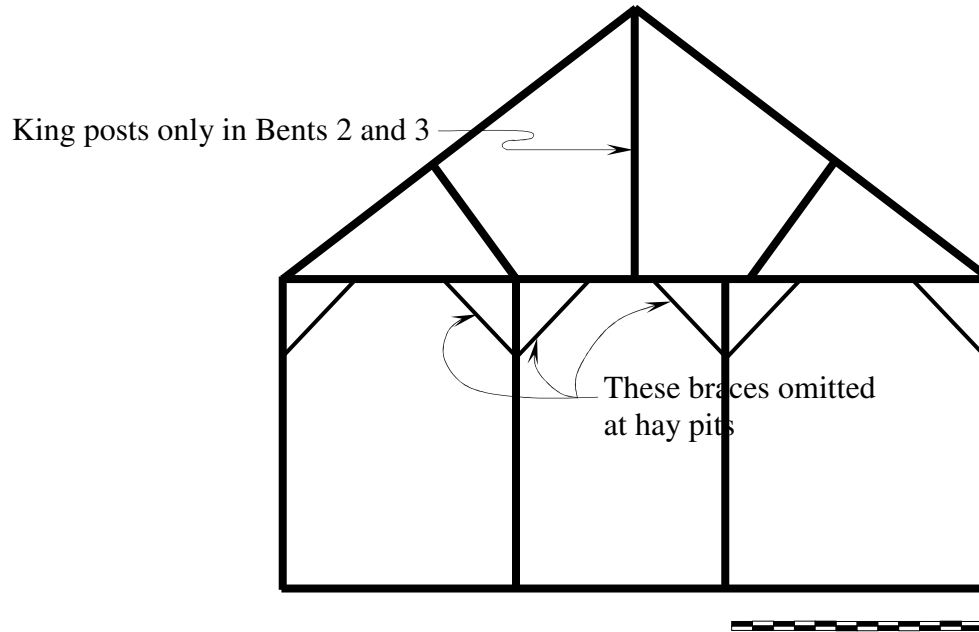
Each bent is laid out approximately as shown below. Braces were originally omitted in a few locations, and have been removed in a few other locations. The king posts are found only on Bents 2 and 3, and are linked by a truss system that stiffens the frame above one of the two original hay pits.

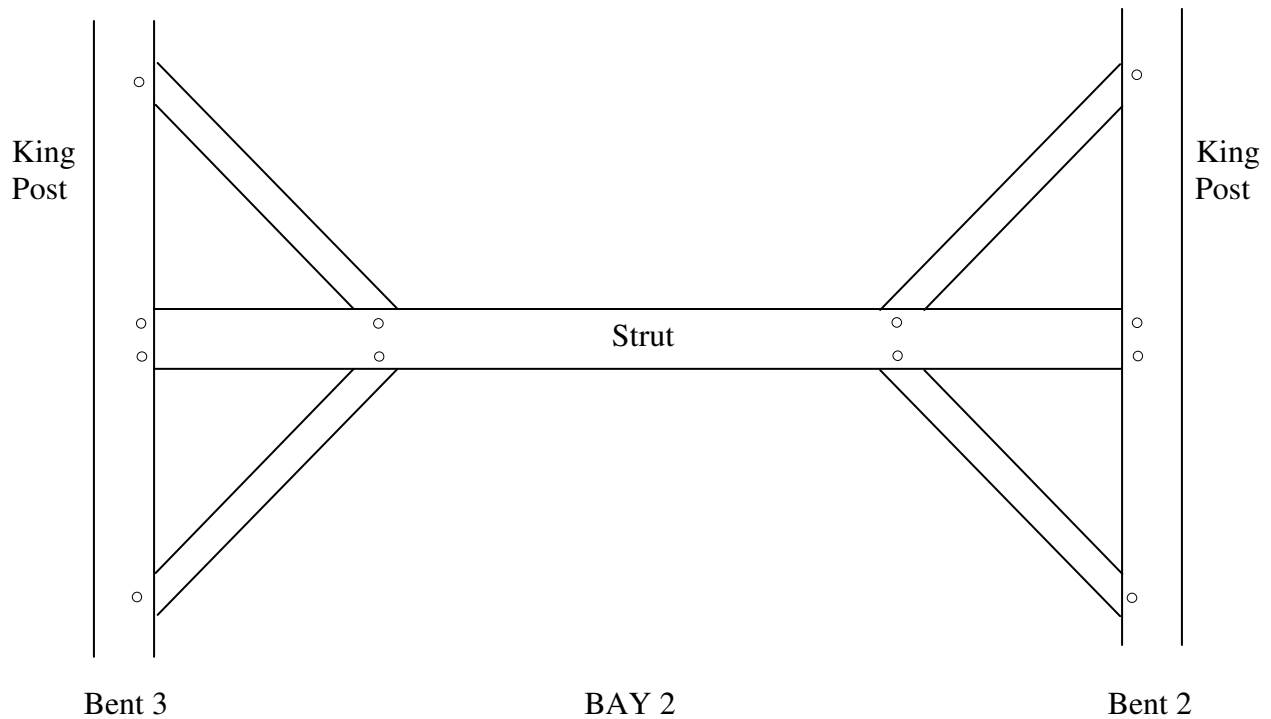
The king posts at bents 2 and 3 are linked by horizontal struts and braces in the manner usually seen in meeting house frames:

The hay pits originally extended across the both sides of Bays 2 and 3. There is no clear reason why the type of bracing shown above was not extended across both of these bays rather than being limited to Bay 2. The stiffening effect of this single strut was evidently considered sufficient to resist deformation of the entire roof frame.

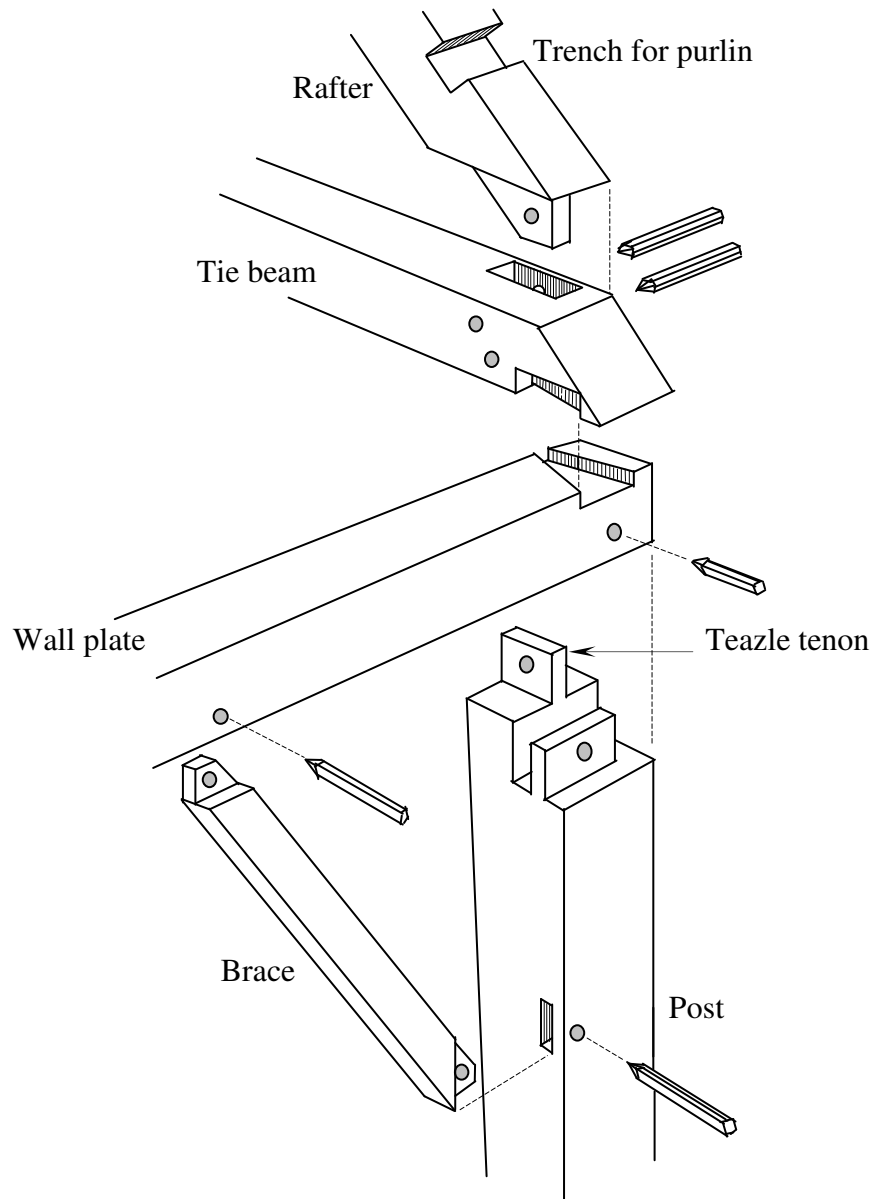
The barn has an extremely heavy frame, laid out according to the “scribe rule,” by which the members that intersect each joint are careful and individually scribed and cut to fit tightly. The frame utilizes a complex joint at the juncture of posts, wall plates, tie beams and rafters. This joint is defined by timber framers as the “English tying joint.” It is shown below, exploded to reveal some of the hidden features of this intersection.

The massive posts, dropped wall plates, and the tie beams secured by teasele tenons all replicate features seen during the seventeenth and eighteenth centuries on the New Hampshire seacoast.
